ABODO WOOD LTD FIRE TEST REPORT

SFM 12-7A-1 TESTING ON EXTERIOR WALL ASSEMBLY CONTAINING ABODO VULCAN T&G WOOD SIDING PLANK INSTALLED IN THE VERTICAL ORIENTATION

K5893.01-121-24-R0

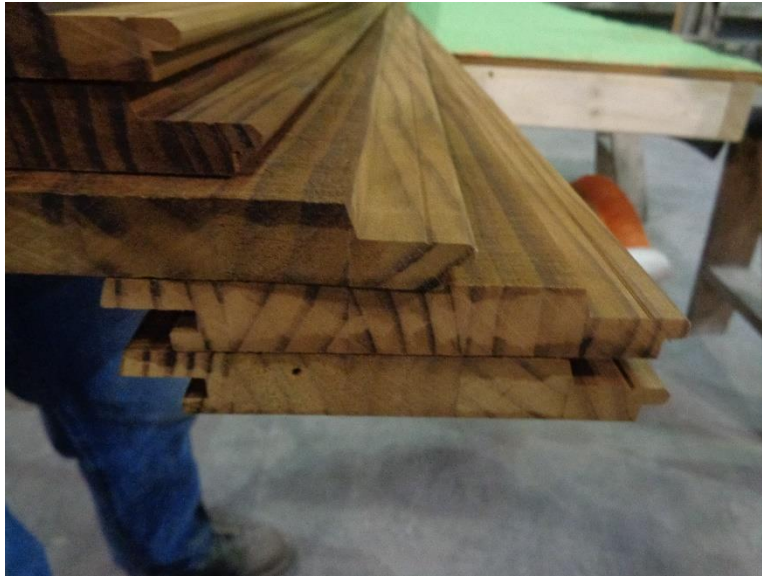
Photo No. 1
Exterior Cladding Profile

Abodo Vulcan T&G wood siding planks were used as the exterior cladding. The siding planks were mounted in a vertical orientation with the long dimension parallel with the framing members. The siding planks were 5-5/8 in. x 3/4 in. thick x 8 ft. long. The planks utilized a tongue and groove that when installed created a 3/8 in. joint between the next plank that is installed. The planks were secured to the assembly using a #7 stainless steel wood screw placed on 16 in. centers.

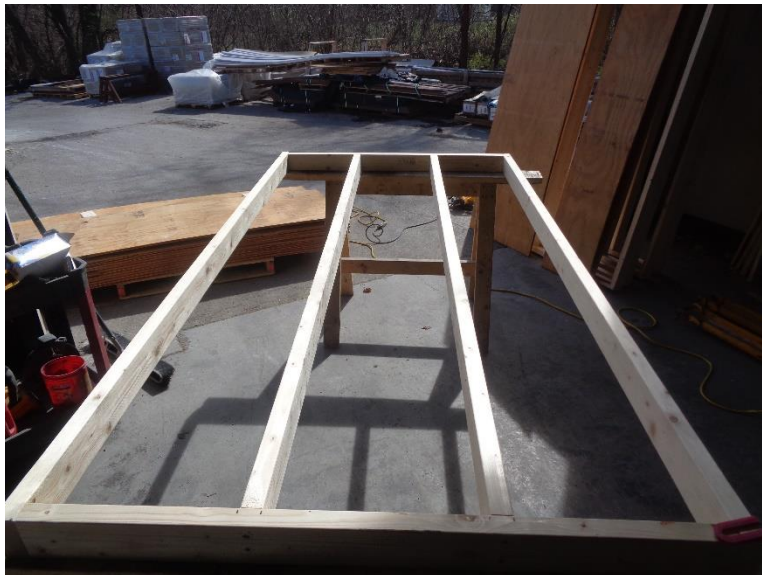
Photo No. 2
Framing Complete

Dimensional lumber measuring a nominal 2 in. x 4 in. x 96 in. long were used as the framing "studs" of the assembly. These framing pieces were placed on 16 in. centers. The same size of framing pieces was cut to 48 in. long as used as a header and sill piece. These pieces were nailed to each stud framing piece using a 3-1/2 in. long 8d nail. The wood components used for the assembly framing were verified to have less than a 12% moisture content.

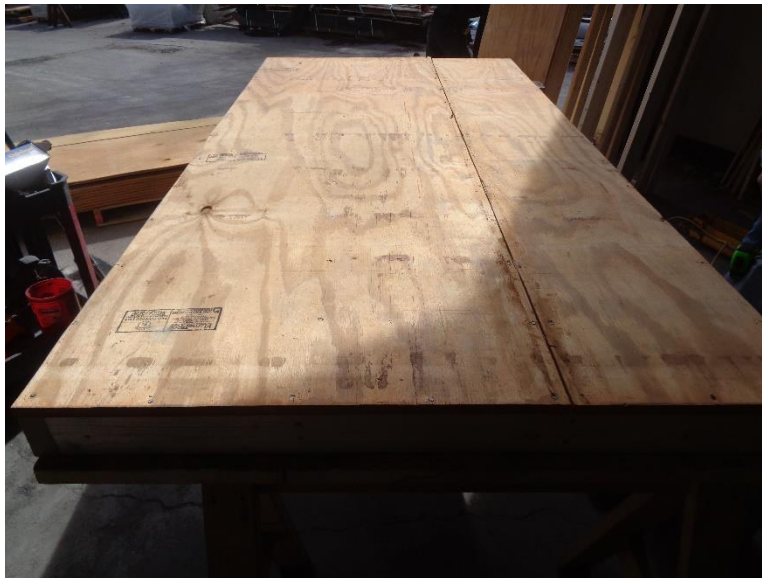
Photo No. 3
Sheathing Installed

5/8 in. thick flamePro plywood was used as the sheathing. This sheathing had a vertical joint on a vertical stud 16 in. from the assemblies centerline. This sheathing was secured to the framing using 2-1/2 in. long 8d nails. These nails were placed 8 in. on center around the perimeter and 12 in. on center in the field of the plywood. The sheathing used for the assembly was verified to have less than an 8% moisture content.

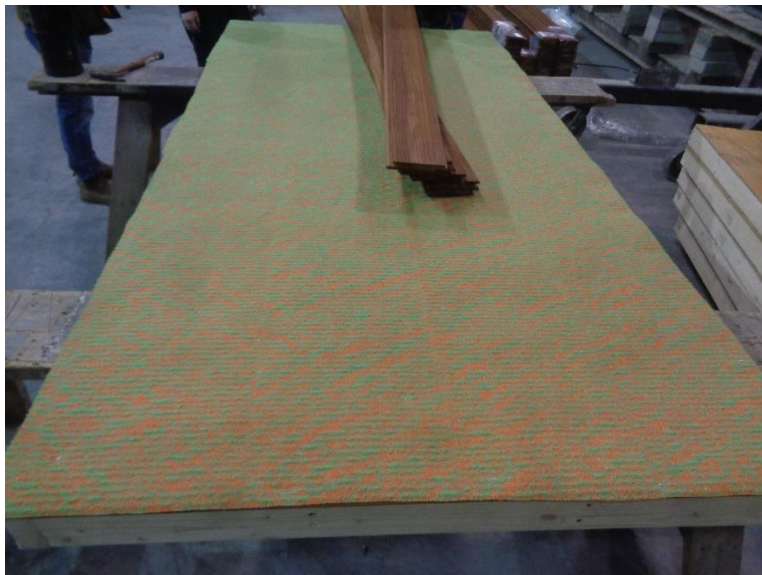
Photo No. 4
Water/Air Barrier Installed

VaproShield® Wrapshield™ RS 3mm water resistive vapor permeable air barrier membrane was used on this assembly. This barrier was secured to the assembly using 5/16 staples on nominal 12 in. centers.

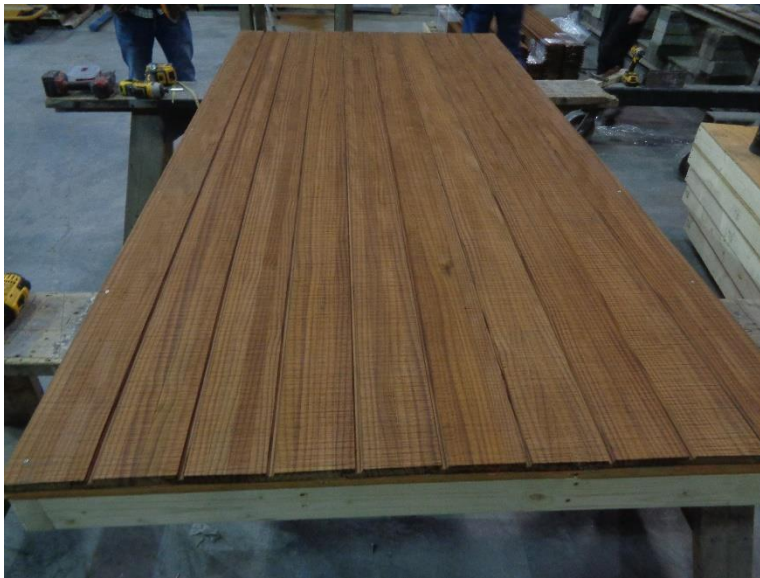
Photo No. 5
Cladding Installed

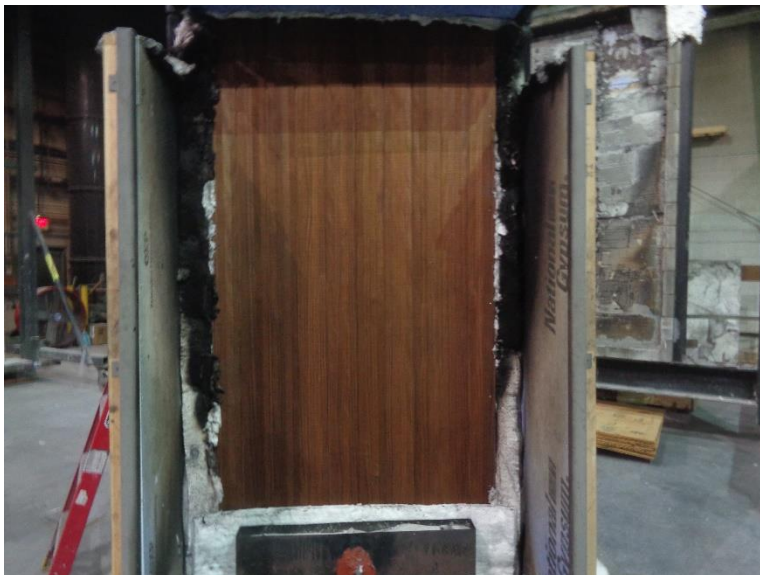
Photo No. 6
Complete Assembly (Exterior Surface)

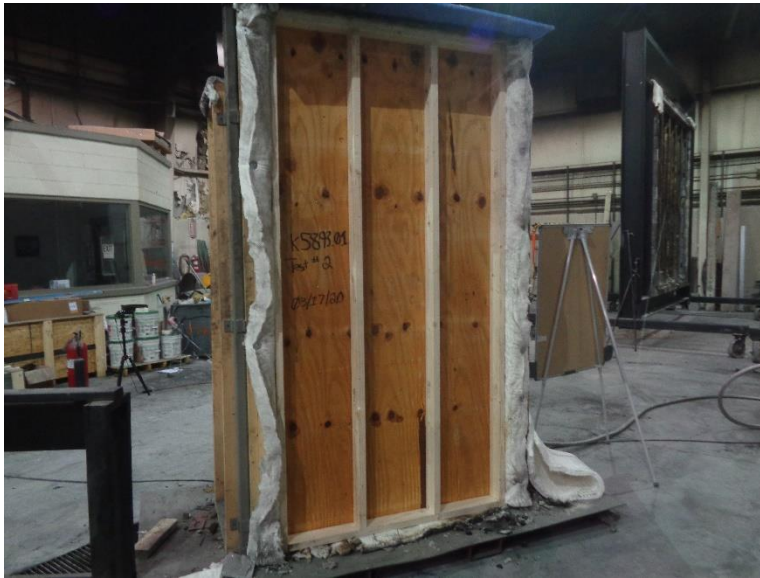
Photo No. 7
Complete Assembly (Interior Surface)

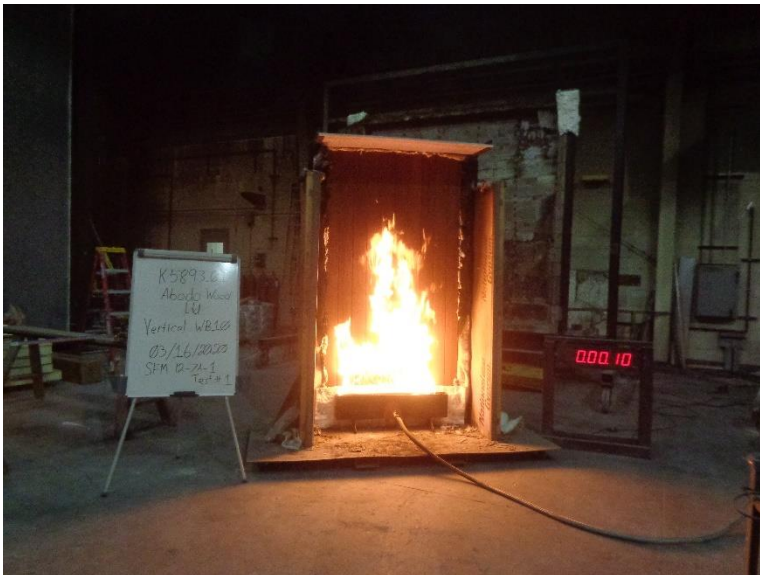
Photo No. 8
Ignition of Burner

The test specimen is installed into the fixture and centered underneath of the combustion collection system. The ignition source for the test is a gas burner with a 4 inch by 39-inch diffusion adapter filled with a minimum 4-inch layer of Ottawa sand. The top surface of the burner through which the gas is applied is positioned 12 inches above the floor. The burner is centered inside of the fixture and is placed in contact with the surface of the specimen. The gas supply to the burner is C.P. grade propane (99 percent purity). The burner is set to produce a gross heat output of 150 ± 8 kW for ten minutes. The flow rate is metered throughout the test. The gas burners are controlled with mass flow meters to control the volume of gas to match the heat outputs of the standard. At the end of the ten-minute burn period, the burner is shut off and all instrument readings are stopped. Post-test observations are made for an additional 60 minutes or until all evidence of combustion is no longer visible. The test procedure is repeated to a total of three total tests.

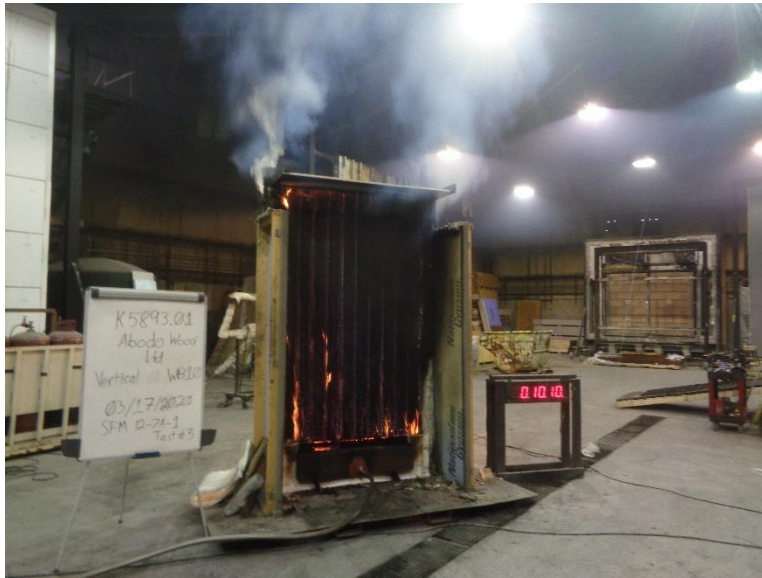
Photo No. 9
Burner Off

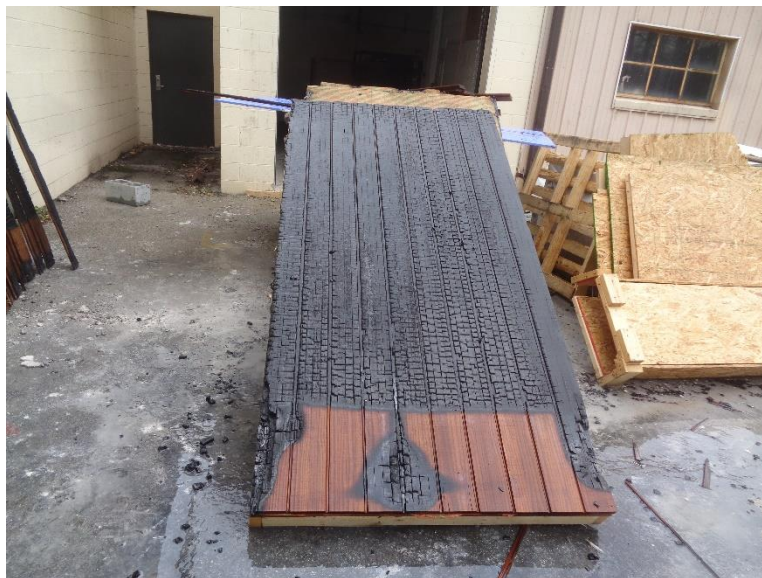
Photo No. 8
Post-test Exterior

TEST REQUIREMENTS	TEST RESULTS	PASS/FAIL
Absence of flame penetration through the wall assembly at any time.	Flame penetration through the assembly was not observed during the full duration of the three tests.	PASS
Absence of evidence of glowing combustion on the interior surface of the assembly at the end of the 70-minute test.	Evidence of glowing combustion on the interior surface of the assembly at the end of the 70-minute duration for all three tests was not present.	PASS

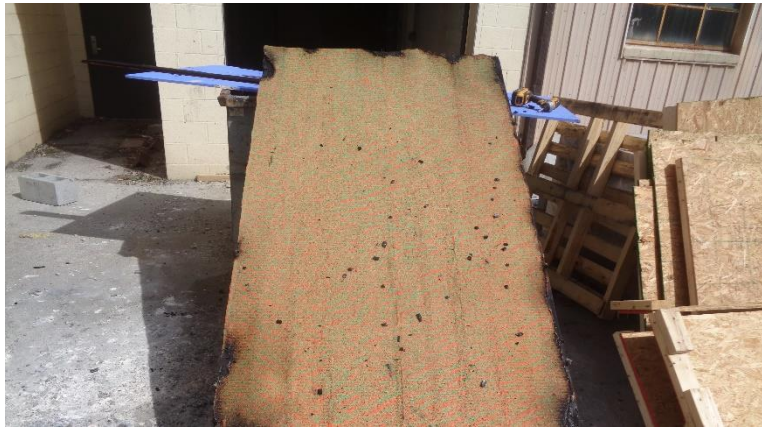
Photo No. 9
Exterior Cladding Removed (Post-Test)

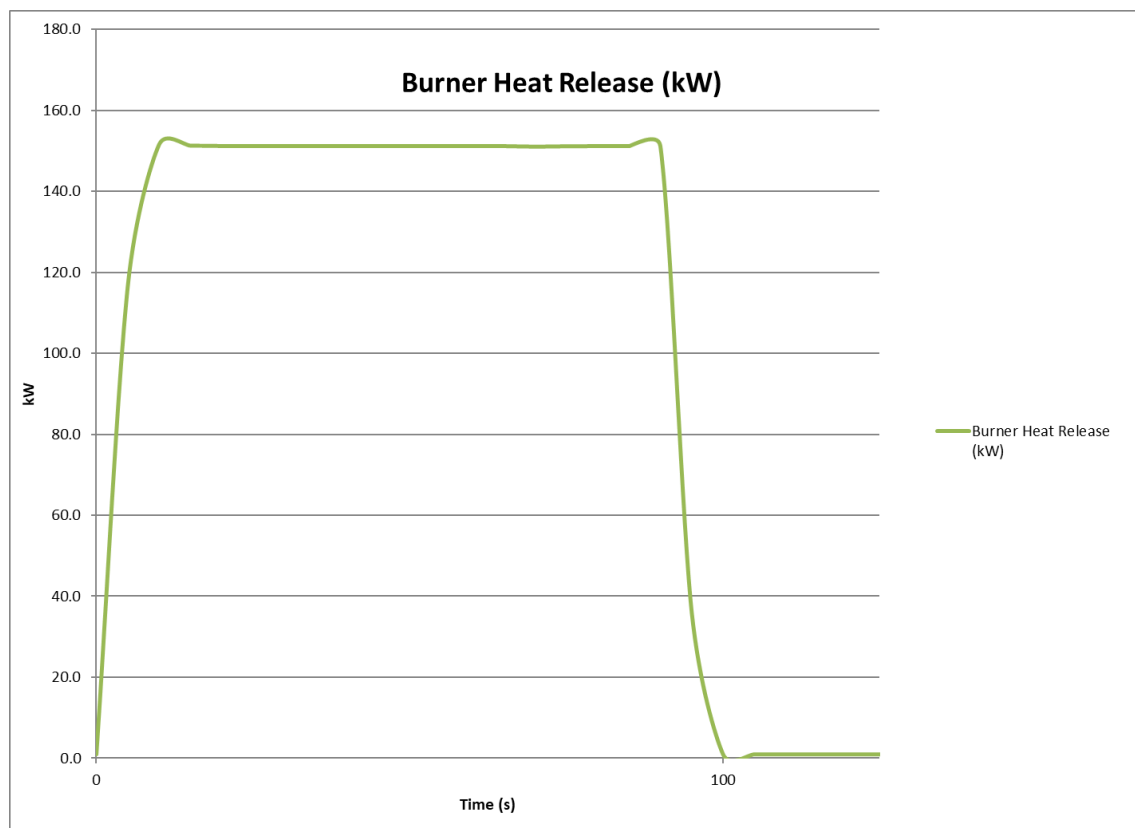
Graph No. 1
Burner Output Verification Data
